Inspection Report

Property Address:
77-1234 Aloha Coast
KAILUA-KONA HI
96740

Weinmann Home Inspections

Date: 5/24/2014	Time: 12:00 PM	Report ID: 1202
Property: KAILUA-KONA HI 96740	Real Estate Professional:

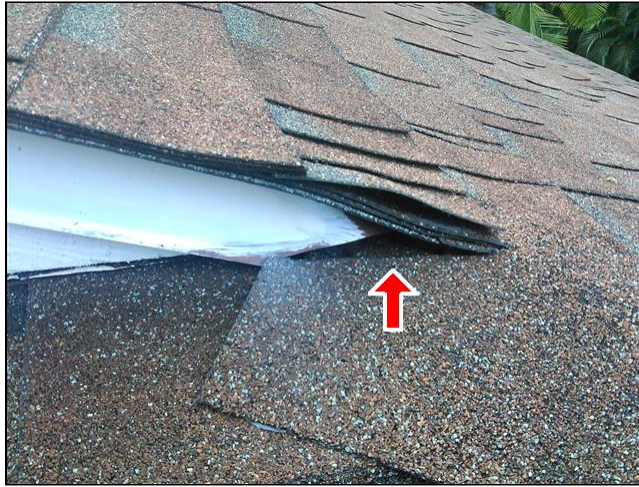
Possible leak. Needs to be calked.

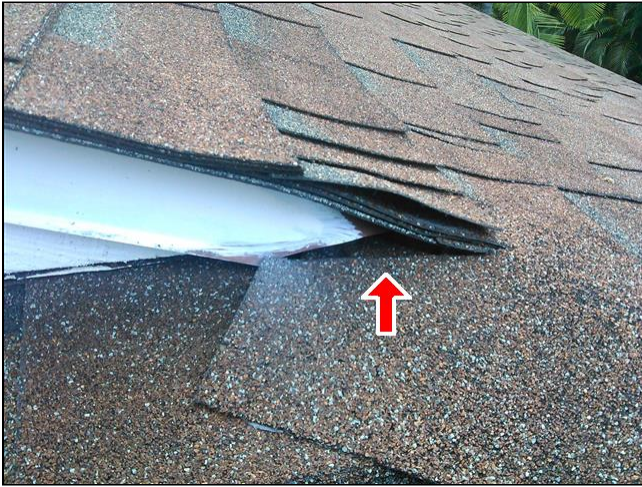
1.0 Item 1(Picture)

- The roof covering is nearing the end of its life cycle at the "entire roof". Roof covering will need replacing before 5 years. A qualified contractor should inspect and repair as needed. This area will need some maintenance.

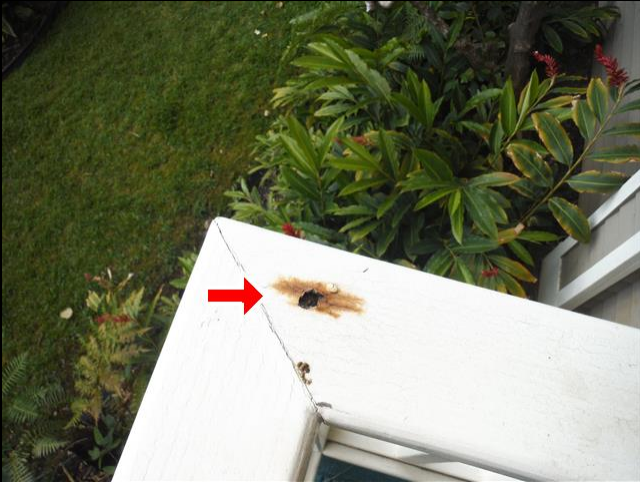
2.3 Item 1(Picture)

2.3 (1) The hand/guard rail for the stairs to basement is damaged. Further deterioration can occur if not prepped and sealed or painted. A qualified contractor should repair or replace as needed.

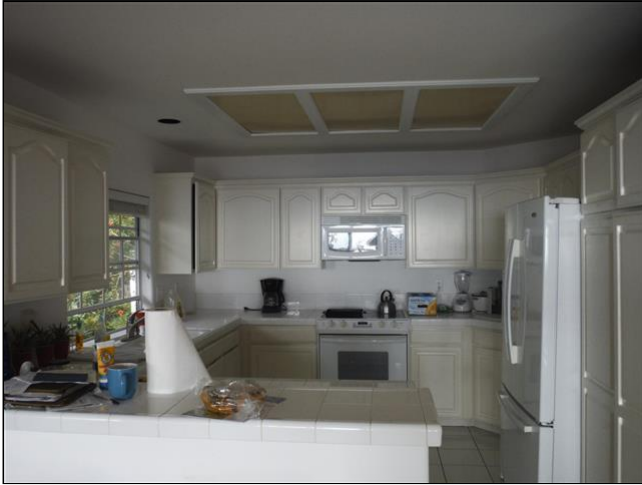
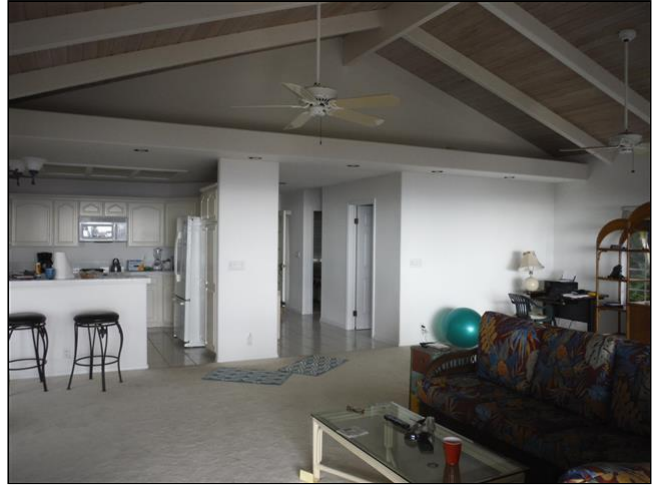
4.3 (2) The hand/guard rail for the stairs to basement damaged. Further deterioration can occur if not prepped and sealed or painted. A qualified contractor should repair or replace as needed.

4.4 (1) Two of the upper cabinet doors were installed upside down located above the refer. recommend a qualified cabinet worker fix them.

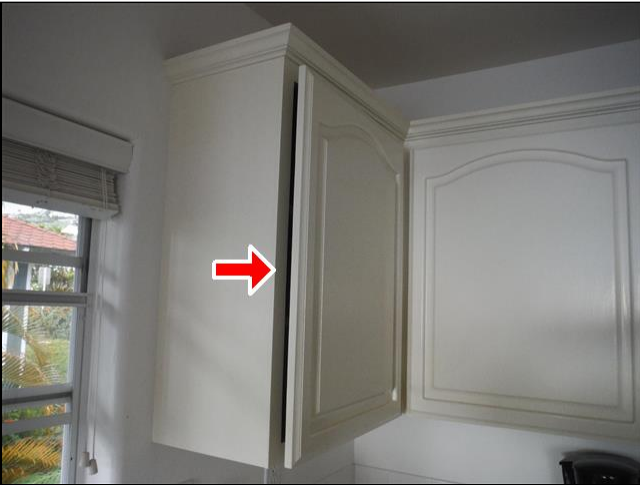
4.4 Item 2(Picture)

4.4 (2) Some cabinet doors need magnets or hardware to stay shut.

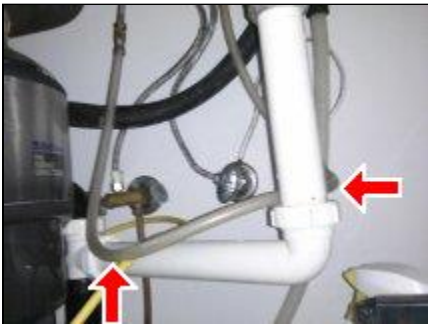
6.1 Item 1(Picture) kitchen sprayer hose leaking

6.1 The spray nozzle leaks at the kitchen sink. Repairs are needed. A qualified person should repair as necessary.

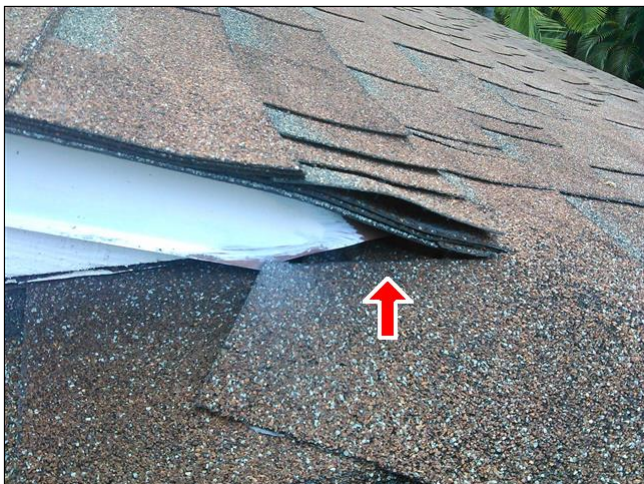
1.0 Item 1(Picture)

- The roof covering is nearing the end of its life cycle at the "entire roof". Roof covering will need replacing before 5 years. A qualified contractor should inspect and repair as needed. This are will need some maintenance.

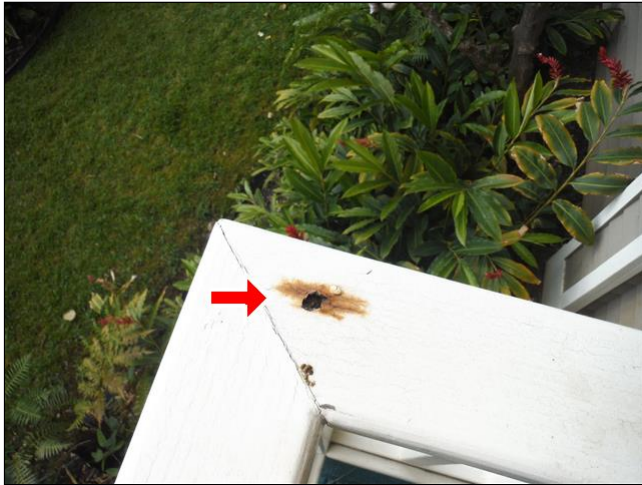
2.3 Item 1(Picture)

(1) The hand/guard rail for the stairs to basement is damaged. Further deterioration can occur if not prepped and sealed or painted. A qualified contractor should repair or replace as needed.

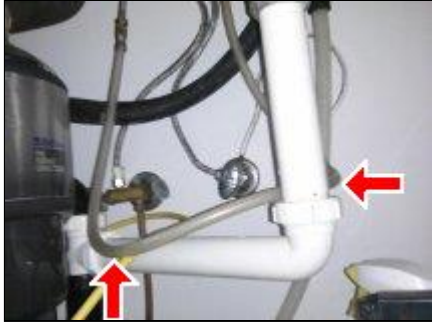
6.1 Item 1(Picture) kitchen sprayer hose leaking

The spray nozzle leaks at the kitchen sink. Repairs are needed. A qualified person should repair as necessary.
